General Service Bulletin

Temperature Sensor Removal and Installation Practices Product Code: 0047 (CVHS), 0153 (RTHD), 0154 (RTAC), 0347 (CDHF, CDHG, CVHE, CVHF, CVHG, CVHL), 0664 (CGAM), 0703 (RTWD, RTUD), 0895 (RTAE),

RF-SVB012A-EN

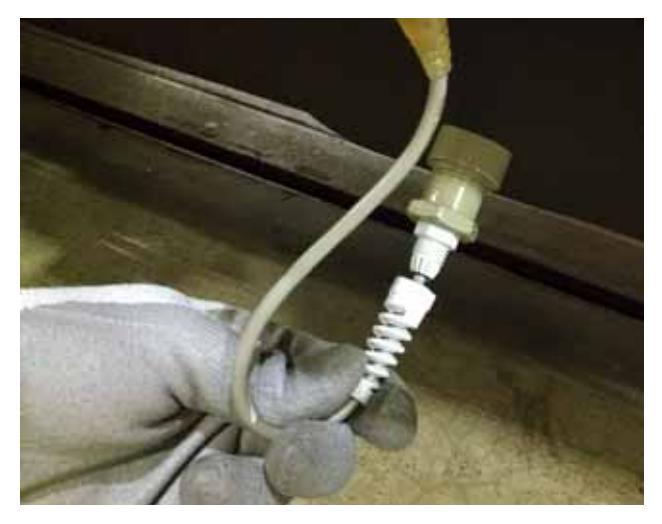
Evaluation of many of the temperature sensor returned for failure analysis has revealed that many have broken probe wires, that is, the wires between the encapsulated printed circuit board and the thermistor (probe). The temp sensor probe consists of only two 22 AWG wires and are not as robust as the four 18 AWG machine buss wires. Therefore, it is believed that many of these failures are the result of improper removal or installation practices. This service bulletin provides proper installation, removal, and handling practices.

- Dry off the connector and cables if wet before disconnecting the sensor to prevent water from getting into the connector. Moisture in the connector can lead to corrosion of the leads.
- Unthread the spiral strain relief from the crimping nut; see Figure 1.
